# Landscape Plant Lists for Salt Tolerance Assessment

U.S.D.I.  
Bureau of Reclamation

April 2004

S. Miyamoto, I. Martinez, M. Padilla, A. Portillo  
Texas A&M University Agricultural Research and Extension Center at El Paso  
Texas Agricultural Experiment Station

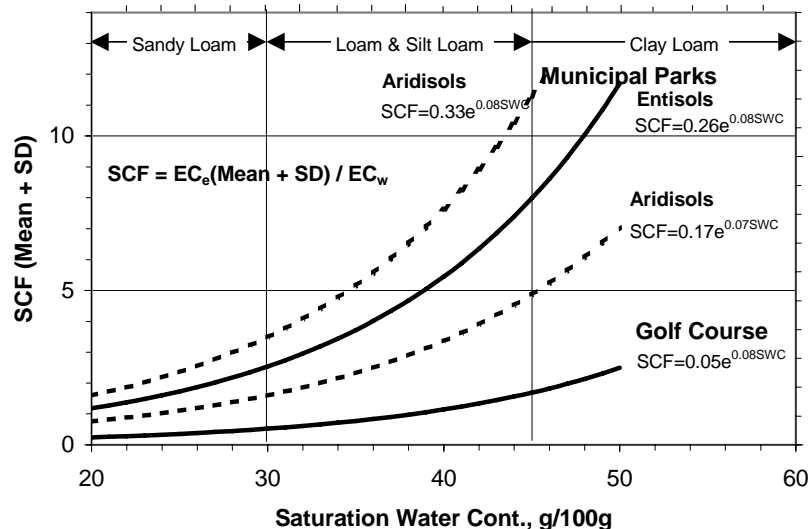
## Appendix: Salt Concentration Factors

Appendix I. The salt concentration factor (SCF) expressed as the mean plus the standard deviation (SD) as related to the saturation water content or soil textures of golf courses and municipal parks. The lines drawn are the best fit lines based on actual soil salinity measurements.

Once soil and water testing results are obtained, the salt concentration factor (SCF) should be estimated by dividing soil salinity ( $EC_e$ ) with salinity of irrigation water ( $EC_w$ ). This parameter is a measure of salt accumulation potential, and varies not only with soil type, but also with soil and irrigation management practices used. Examples are shown in Appendix for municipal parks and golf courses in the El Paso area. If the SCF determined for a given site exceeds what is shown in the appendix, the causes of high levels of salt accumulation should be investigated prior to attempting to look for salt tolerant plants. The common causes include inadequate irrigation, high clay contents, and soil compaction.

If salinity of irrigation water is expected to change, soil salinity upon conversion can be estimated by multiplying the projected salinity of the irrigation water to the SCF. If no soil salinity data are available, determine SCF in a similar soil type under a similar land use, or use Appendix for an estimate. The SCF increases with increasing clay contents of the soil (or the saturation water content) and with soil compaction.
